The Performance of House Foundations in the Canterbury Earthquakes

Master of Engineering in Civil Engineering

Duncan Henderson

August, 2013

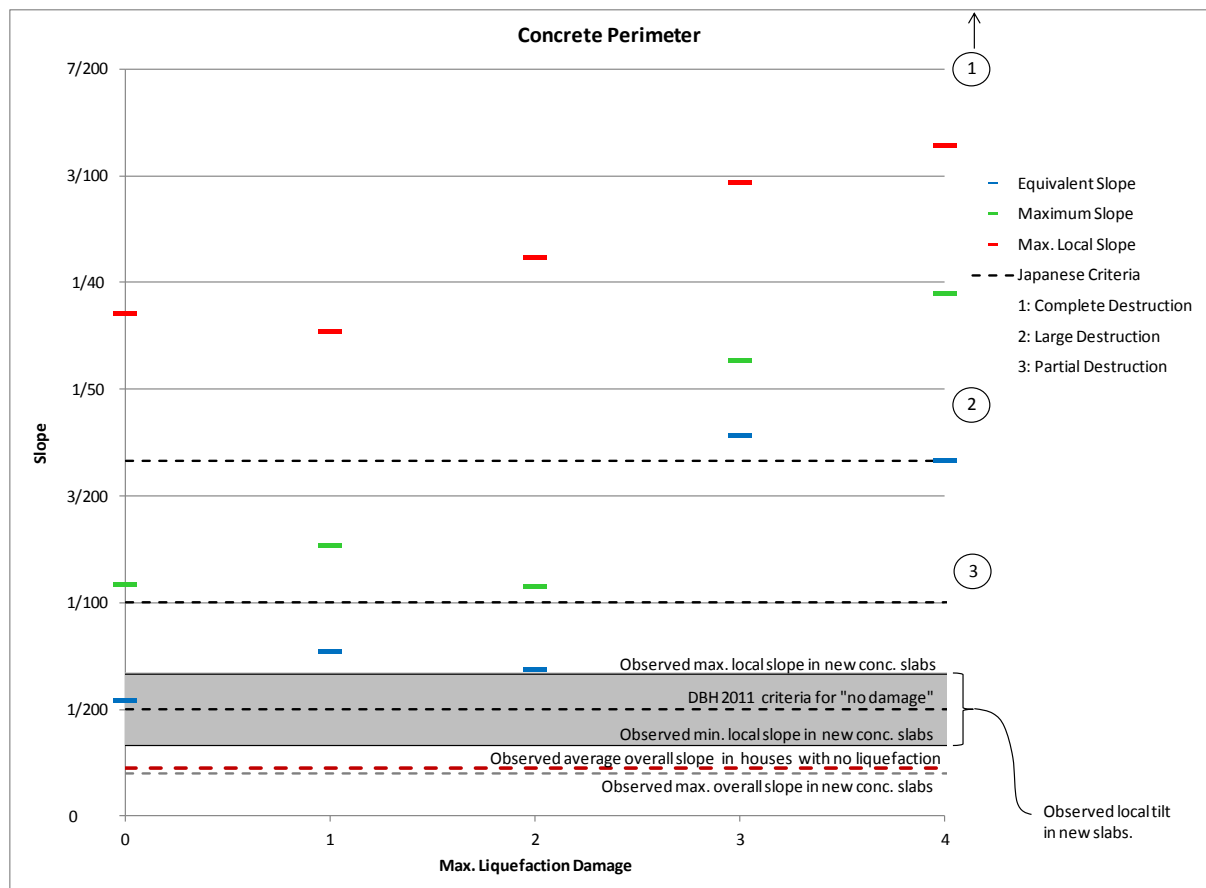
Figure 4.34 shows that, in general, the median floor slope increases for increasing liquefaction severity, agreeing with the general trend discussed in Section 4.7.2.1. The performance of concrete perimeter foundations when viewing Figure 4.34 is generally considered to be poor. The median values for the equivalent slope exceed the DBH (2011) criteria for a ‘non-damaged’ foundation of 1/200 at all levels of liquefaction, including where no surface ejecta was found. This suggests that concrete perimeter foundations subjected to any small degree of liquefaction loading will require some repairs.

Figure 4.34. Median values for the three different floor slope parameters for each level of liquefaction severity for concrete perimeter foundations.

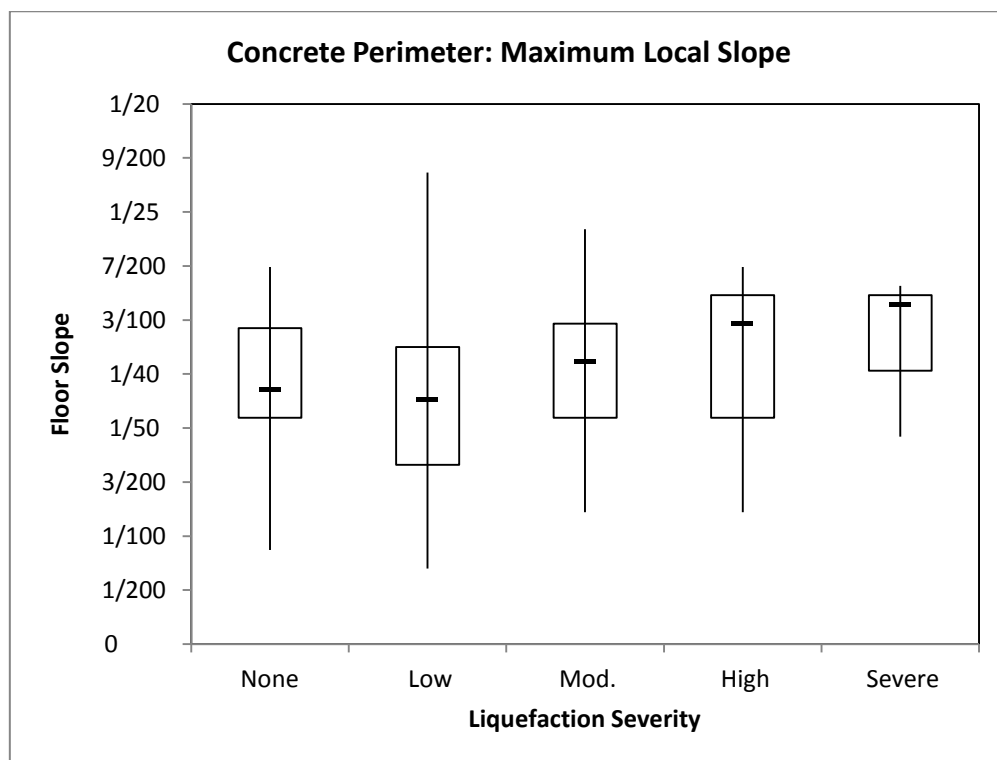
Figure 4.35. Box & Whisker plot for the maximum local slope of concrete perimeter foundations for each level of liquefaction severity.

The median maximum floor slopes are higher than the corresponding equivalent floor slope at every level of liquefaction, and are all above the Japanese criteria for partial destruction of 1/100. The median maximum local slopes at each level of liquefaction are even higher, and are all considerably higher than the Japanese criteria for large-scale destruction of 1/60. The median maximum local slopes are also consistently high, emphasised in the full box and whisker plot in Figure 4.35. The overall range of maximum local slopes recorded does not really increase with increasing liquefaction severity, unlike what is seen in the median values for maximum and equivalent floor slope. Even with no surface manifestation of liquefaction (i.e. 'none' in Figure 4.35), the median maximum local floor slope is almost 1/40, with the lowest local floor slope recorded close to the Japanese criteria for partial destruction of 1/100. For the no-liquefaction inspections in Figure 4.29, the average maximum local slope is at 1/100, much lower than the median values in Figure 4.35. This shows that once any small level of ground softening occurs, large localised slopes can occur in concrete perimeter floors. And if ground softening and liquefaction go beyond this, these local slopes are unlikely to increase very much. This is due to the flexible construction of this foundation type, which allows the floor humping deformation modes discussed in Section 4.5.3.

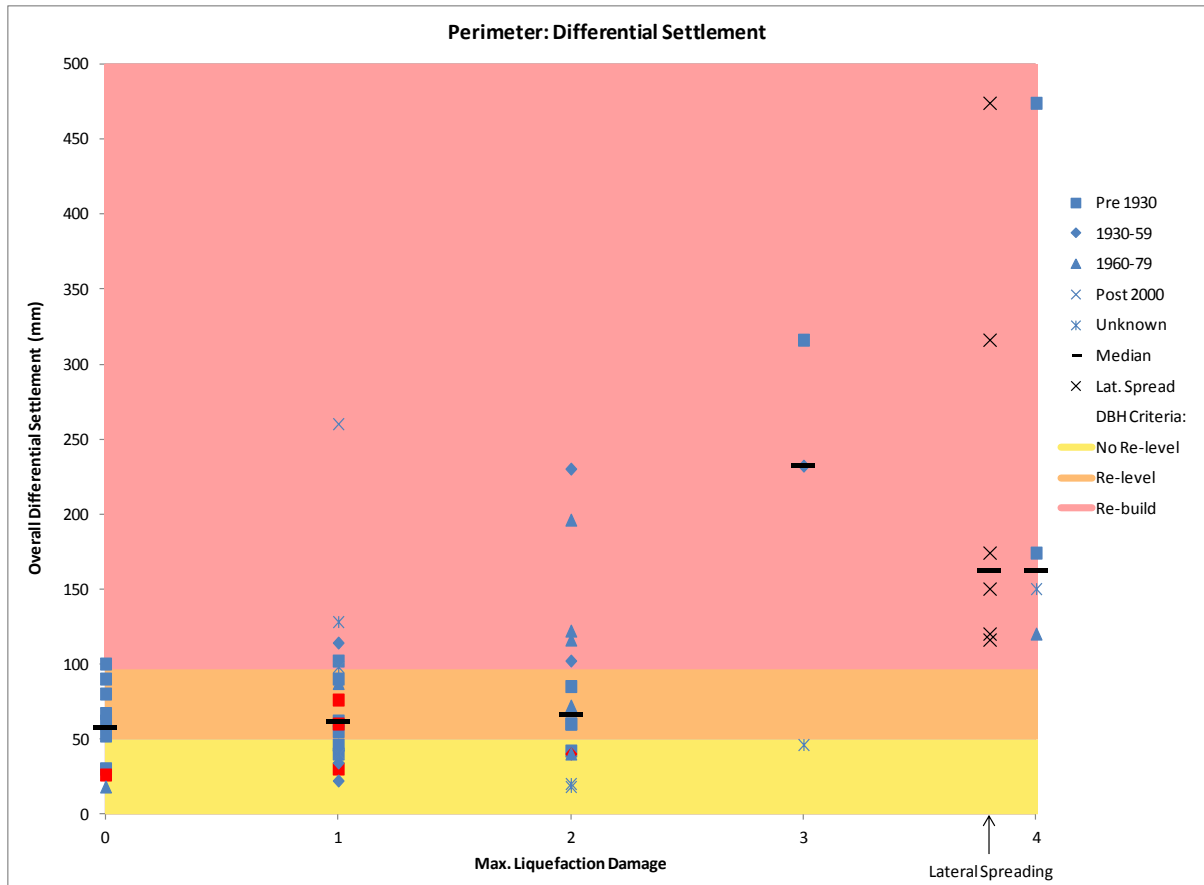
Figure 4.36 shows the raw data and median values for overall differential settlement at each severity of liquefaction damage. These are compared against the MBIE (2012) criteria for whether a foundation repair or rebuild is required. It can be seen that only a small number of concrete perimeter foundations inspected were below the threshold for requiring at least repair. Even with no surface manifestation of liquefaction, the median foundation will require repair, as was shown in Figure 4.34. Although no foundations inspected at this level required re-builds, foundations suffering low or moderate liquefaction are likely to need repair, and possibly rebuilding, with foundations suffering high or severe liquefaction almost always needing to be rebuilt. All foundations suffering significant lateral spreading, also shown in Figure 4.36, would require rebuilding. The two foundations with the highest differential settlements of 316mm and 474mm both suffered significant lateral spreading. This shows that significant lateral spreading is likely to cause significant foundation damage to concrete perimeter foundations.

Figure 4.36. Overall Differential Settlement of concrete perimeter foundations against Maximum Liquefaction Damage, compared to the DBH (2011) criteria for repairing or rebuilding the foundation. Blue values are one-storey and red two-storey houses. Houses suffering significant lateral spreading are also identified.

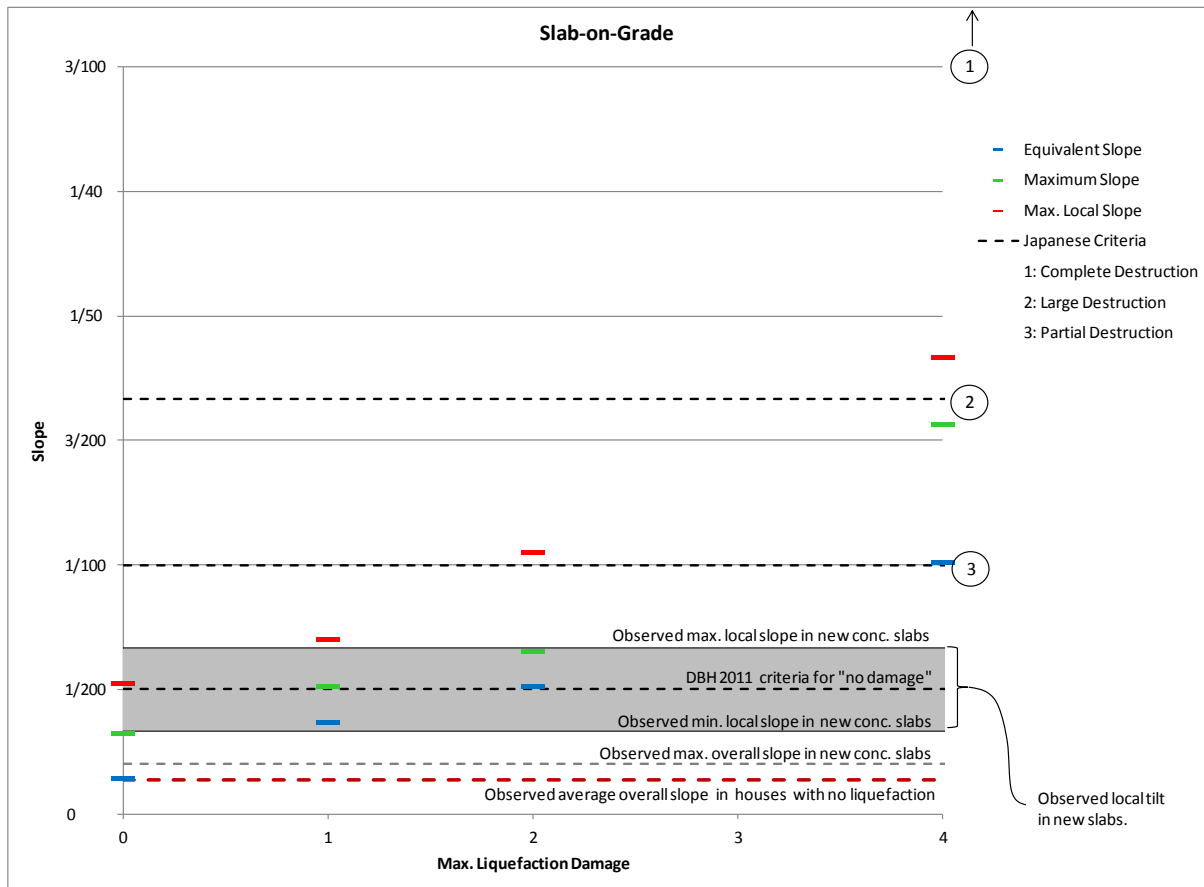
Figure 4.37 shows the median values for the three different floor slope indices at each liquefaction severity level. It shows that for both no and low levels of liquefaction the foundations performed well, and considerably better than concrete perimeter foundations. The maximum local slope in both cases was close to or below the DBH (2011) maximum observed local slope in new concrete slab-on-grade floors of 1/150. The equivalent and maximum floor slopes for no and low liquefaction were also equal to or lower than the DBH (2011) criteria for a ‘non-damaged’ foundation of slope less than 1/200. The median equivalent slope for buildings suffering no surface manifestation of liquefaction was on the average line of 1/720 for the overall slope of houses that were inspected that suffered no liquefaction (i.e. those in Figure 4.13). For severe liquefaction the damage limits were exceeded, but this is to be

Figure 4.37. Median values for the three different floor slope parameters for each level of liquefaction severity for slab-on-grade foundations.

Unlike the data for concrete perimeter foundations, all three slope indices increase at close to the same rate as the liquefaction severity increases. This is to be expected, as slab foundations are more cohesive and less flexible than the timber floors of a concrete perimeter foundation. At low levels, their deformation is more gradual and floor slopes are more even, with less localised deformations. And at high levels of deformation, broken tilting often occurs, with the broken sections tilting uniformly within themselves. This means that at any level of deformation, the three different slope indices are more likely to be closer together than for concrete perimeter foundations where localised floor humping occurs.

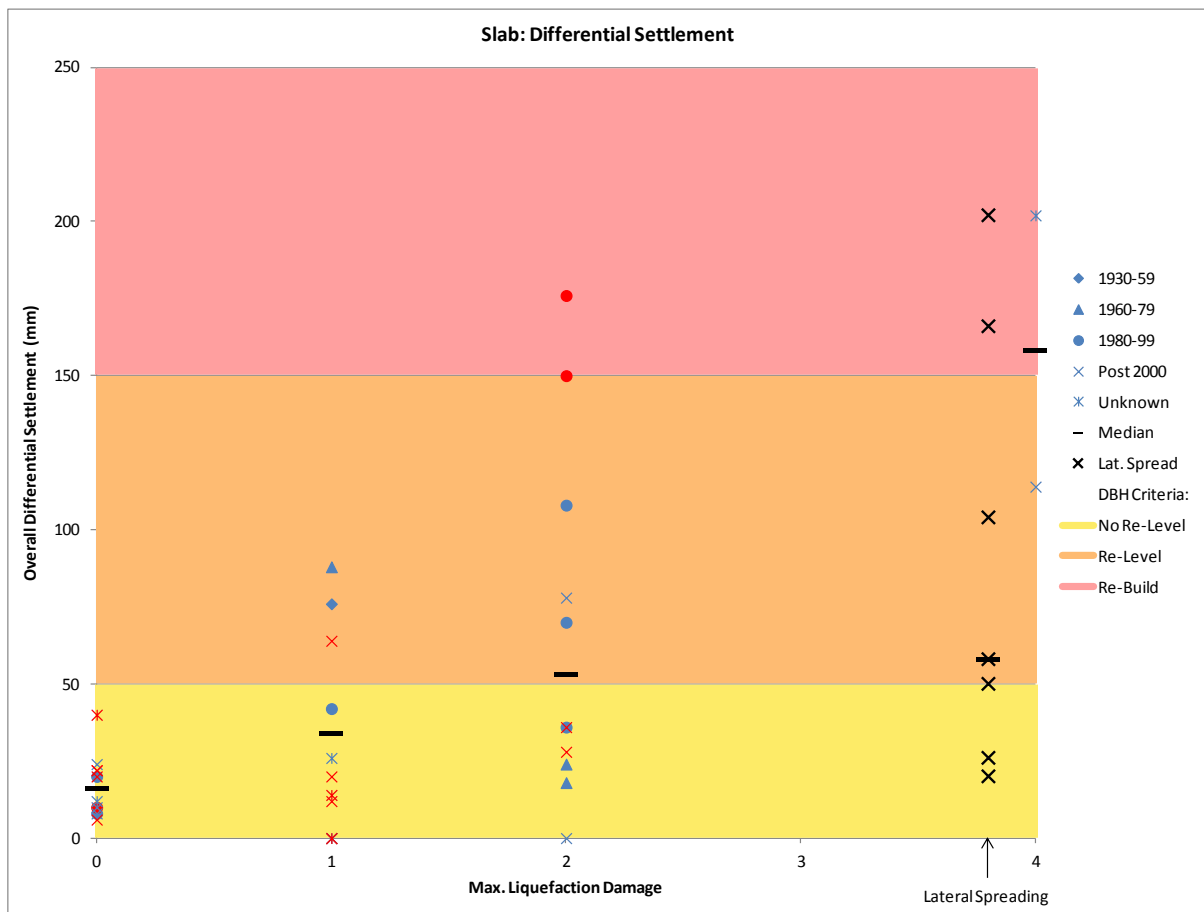
Figure 4.38 contains the slab-on-grade foundation data for differential settlement at each level of liquefaction. It also shows that slab-on-grade foundations performed considerably better than concrete perimeter foundations. There were no foundations with differential settlement above 50mm (i.e. requiring repairs) when no liquefaction was seen on the ground surface, and at low levels of liquefaction, only three of the buildings inspected required repair. The median foundation suffering

moderate liquefaction would need repairing with a differential settlement of 53mm, but at this level of liquefaction there is still a good chance that no repair is required. The lack of data for slabs suffering high and severe liquefaction prevents adequate conclusions from being drawn at those levels, but of all the slab foundations inspected, only a small number needed rebuilding.

Figure 4.38 also shows the differential settlements of the houses which suffered significant lateral spreading. It is clear from these data points that lateral spreading can cause significant deformation in slab-on-grade houses, with only two houses below the no re-level threshold of 50mm differential settlement. Two houses also require rebuilding with differential settlements of 166mm and 202mm.

Figure 4.38. Overall Differential Settlement of slab-on-grade foundations against Maximum Liquefaction Damage, compared to the DBH (2011) criteria for repairing or rebuilding the foundation. Blue values are one-storey and red two-storey houses. Houses suffering significant lateral spreading are also identified.

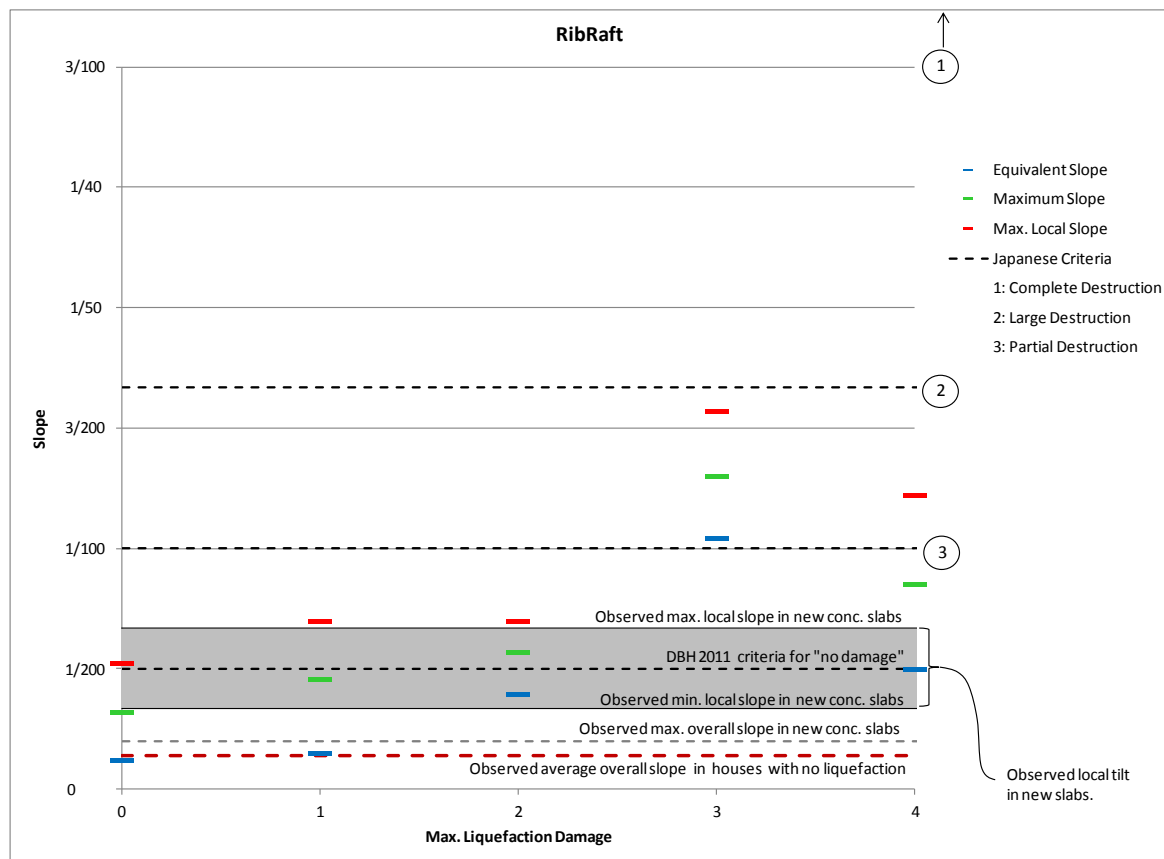
Figure 4.39 shows the median values for the three different floor slope parameters at each level of liquefaction severity for ribraft floors. For liquefaction up to moderate severity, the performance of ribraft foundations was better than for slab-on-grade foundations. The median values for maximum local slope were close to or below the maximum local slope in new concrete floors of 1/150 as found by the DBH (2011). The equivalent and maximum floor slopes for liquefaction up to moderate severity were all close to or below the DBH (2011) criteria for a ‘non-damaged’ foundation of a 1/200

slope, and the median equivalent slope for both no and low liquefaction levels was equal to the average overall floor slope in foundations inspected that didn't suffer liquefaction of 1/720. At high and severe levels of liquefaction the median values for all three floor slopes had higher values, as for the slab-on-grade foundations, again suggesting significant damage under the larger foundation loads. These trends are also found when the floor slope data is graphed against LiDAR ground settlement, the results of which are shown in Appendix N.2.

Figure 4.39. Median values for the three different floor slope parameters for each level of liquefaction severity for ribraft foundations.

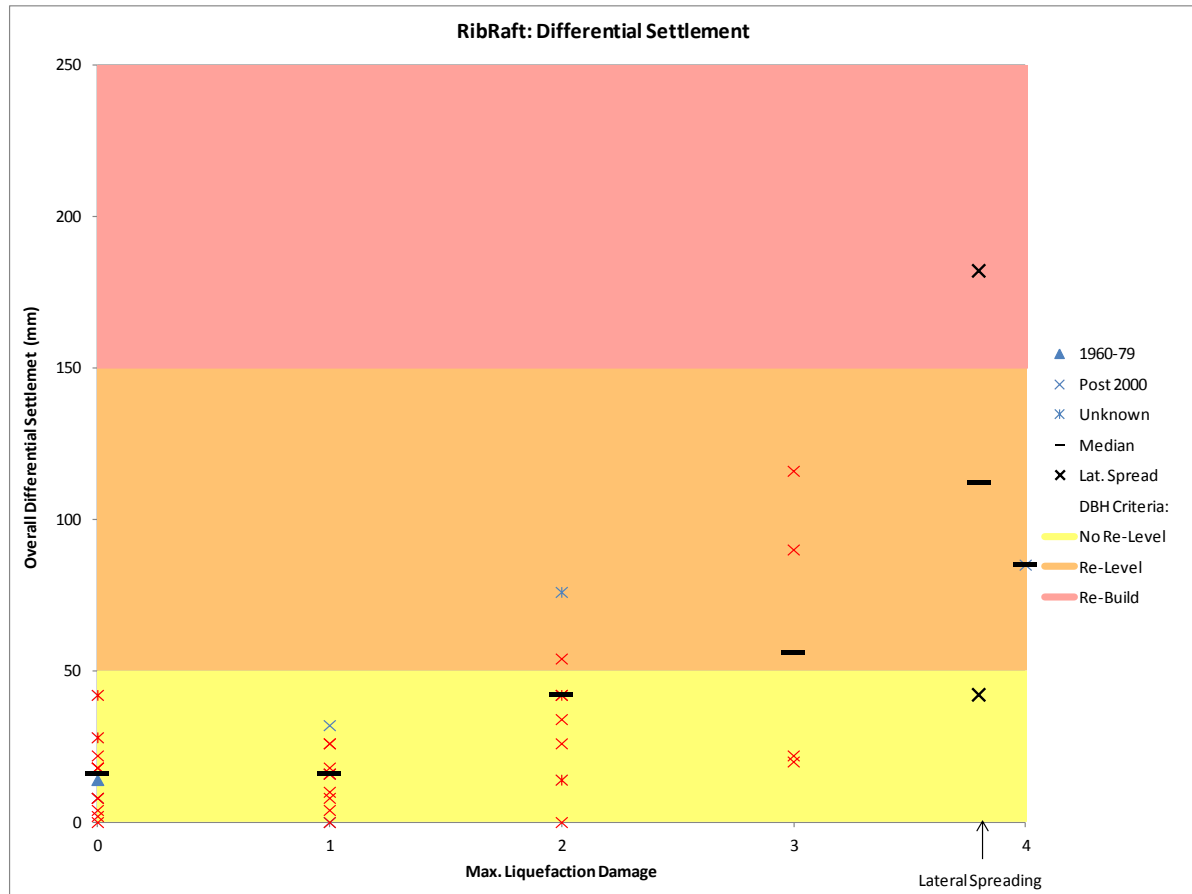
An improvement in performance between ribraft and slab-on-grade foundations is also seen in Figure 4.40 which shows all the ribraft data for differential settlement against liquefaction severity. For none and low liquefaction levels, there were no foundations with differential settlements higher than 50mm and therefore requiring repair. For moderate or high liquefaction, no more than two foundations required re-levels with differential settlements over 50mm. There was one ribraft foundation inspected that required a foundation re-build, but this was considered in the liquefaction analysis as the house suffered significant lateral spreading. As for slab-on-grade foundations, more data is required of foundations suffering high and severe liquefaction severity to draw any definitive conclusions as to whether ribraft foundations required re-building.

Figure 4.40. Overall Differential Settlement of RibRaft foundations against Maximum Liquefaction Damage, compared to the DBH (2011) criteria for repairing or rebuilding the foundation. Blue values are one-storey and red two-storey houses. Houses suffering significant lateral spreading are also shown.

The two ribraft houses inspected that suffered significant lateral spreading, shown in Figure 4.40, suffered very different damage levels. One had a differential settlement of 182mm, requiring rebuilding while the other didn't even need repair, with a differential settlement of 42mm. The one badly damaged house does show that despite the extra strength and stiffness in ribraft foundations, under large imposed deformation and loading they can still be severely damaged.

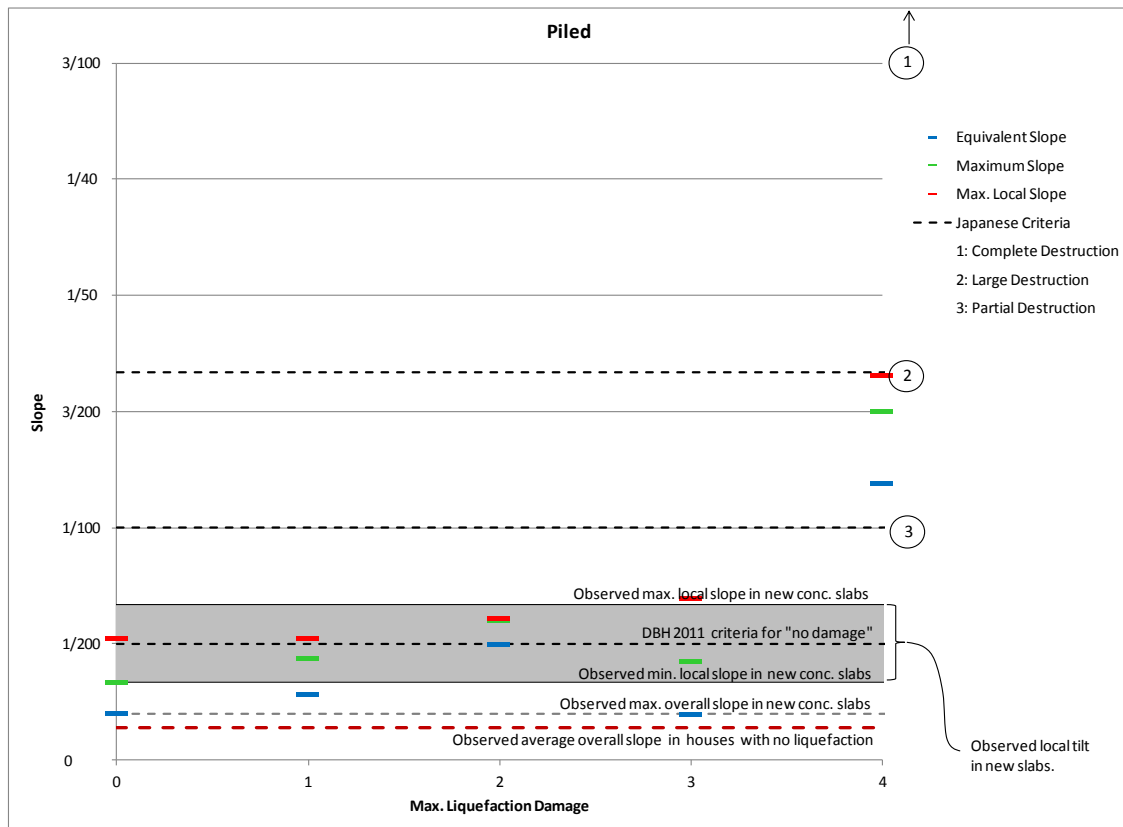
Figure 4.41 shows the median values for all three floor slope indices at the different levels of liquefaction for piled foundations. A lack of data at high and severe liquefaction levels again prevents conclusions being drawn about behaviour under the more extreme ground conditions, but for liquefaction up to moderate severity the performance of the piled foundations is very similar to ribraft foundations, and again better than slab-on-grade foundations. For liquefaction up to moderate severity

the median maximum local slopes were all below the maximum local slope in new concrete slabs of 1/150 from the DBH (2011), showing slightly better performance for local floor deformations than ribraft foundations. The median equivalent and maximum floor slopes are similar and slightly higher than for ribraft foundations, but again all are close to or below the DBH (2011) criteria for a 'non-damaged' foundation.

Figure 4.41. Median values for the three different floor slope parameters for each level of liquefaction severity for piled foundations.

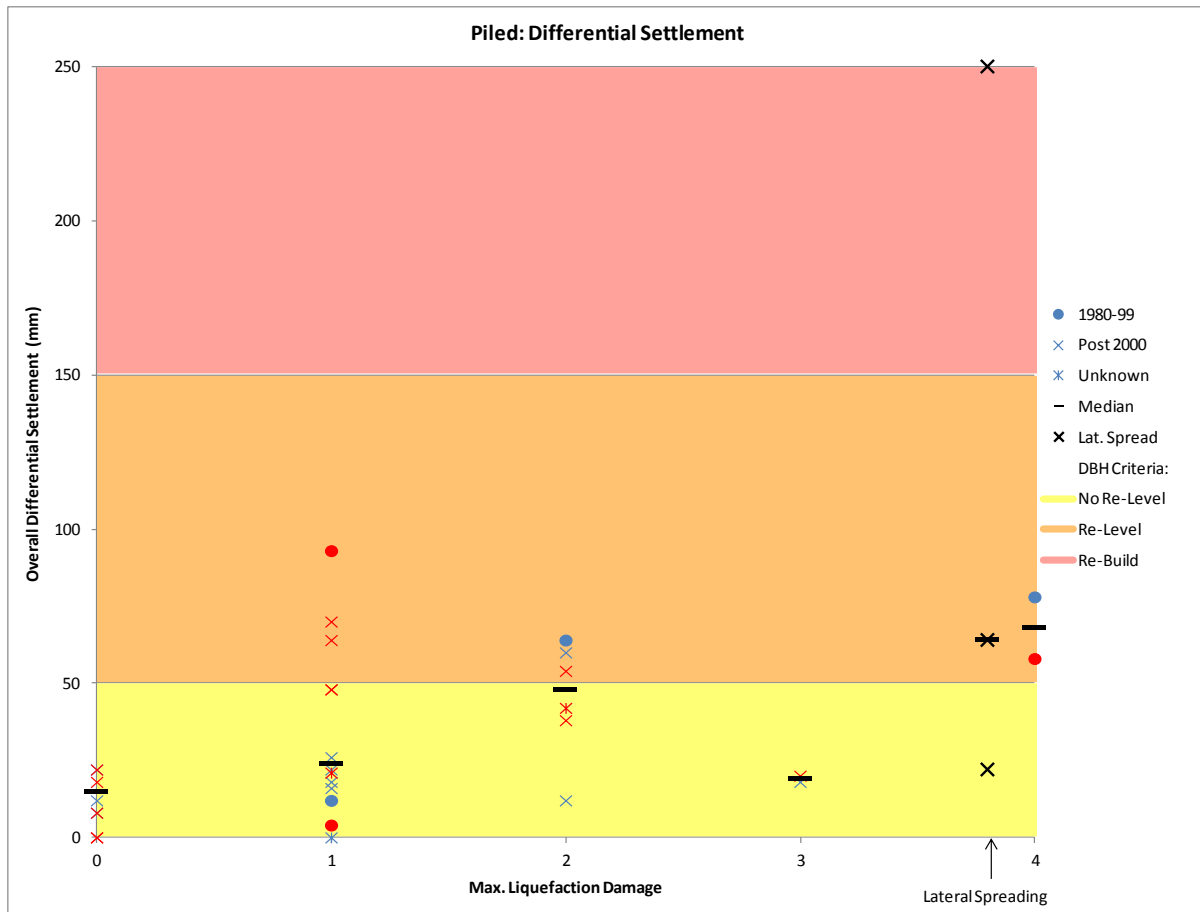
Figure 4.42 shows the differential settlement data for piled foundations at each level of liquefaction severity. It also shows that the performance of piled foundations is better than for slab-on-grade foundations. There are only three piled foundations with differential settlement more than 50mm, and so requiring repair, at low levels of liquefaction. This is the same as for slab-on-grade foundations, but there are also only three foundations requiring repair at moderate levels of liquefaction, with no houses inspected that required a re-build (based on the MBIE (2012) criteria).

There is again a lack of data for high and severe liquefaction, preventing discussion around high land damage, however, like the ribraft slabs, it seems unlikely that many foundations would need re-building. Figure 4.42 also shows the differential settlement of the three piled foundation houses which suffered significant lateral spreading. Two of the houses performed well under the extreme loading, experiencing 22mm and 64mm of differential settlement, with the second one requiring a re-level. However the third house had a differential settlement in excess of 250mm, requiring a foundation re-build. The superstructure of this third house performed very well, as the house was tilting uniformly,

putting little stress on the superstructure. However, due to the deep liquefaction and lateral spreading, a re-build of the foundation would be required.

Figure 4.42. Overall Differential Settlement of Piled foundations against Maximum Liquefaction Damage, compared to the DBH (2011) criteria for repairing or rebuilding the foundation. Blue values are one-storey and red two-storey houses. Houses suffering significant lateral spreading are also shown.

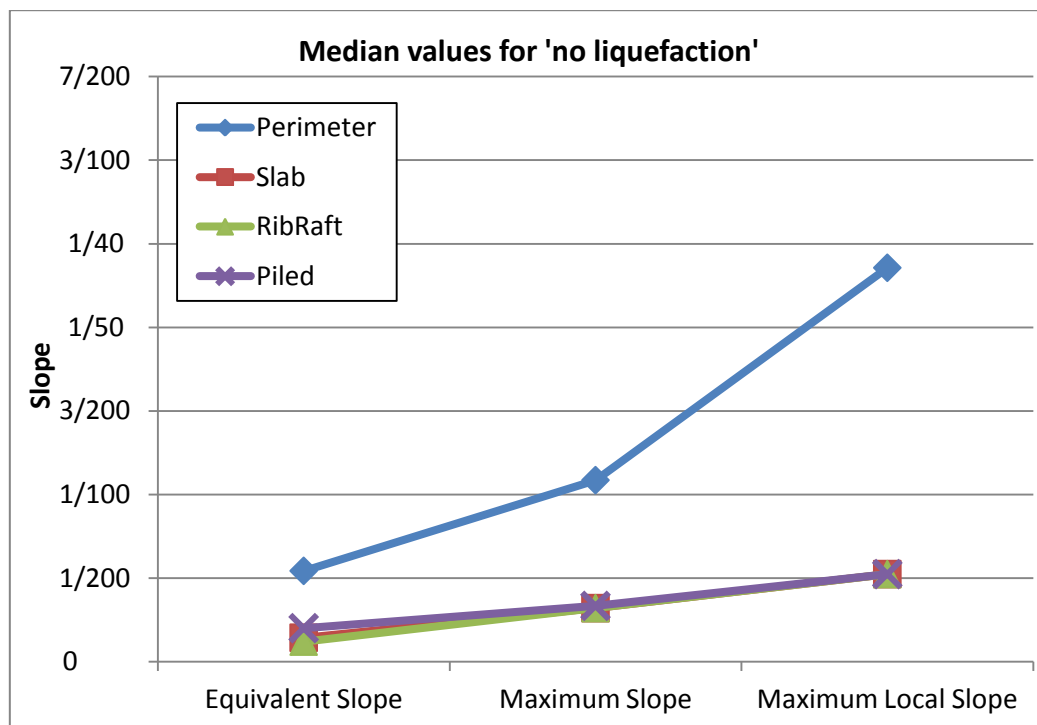
Figure 4.43. Median slope values for each foundation type, for 'no liquefaction', for the three floor slope indices.

As already stated, Figure 4.43 and the additional plots in Appendix N.1.5, show that at low levels of liquefaction, the three slab-based foundation types have very similar median values for all three slope measurements, although for moderate liquefaction slab-on-grade foundations have a higher median maximum local slope than ribraft or piled foundations. This is because at low levels of liquefaction, the loads on the foundation are not high enough to break up any of these three foundation types, so they all deform in a similar way, creating comparable distributions of floor slope. At moderate liquefaction, the loads are getting high enough that the weaker slab-on-grade foundations are beginning to break up causing higher floor slopes.

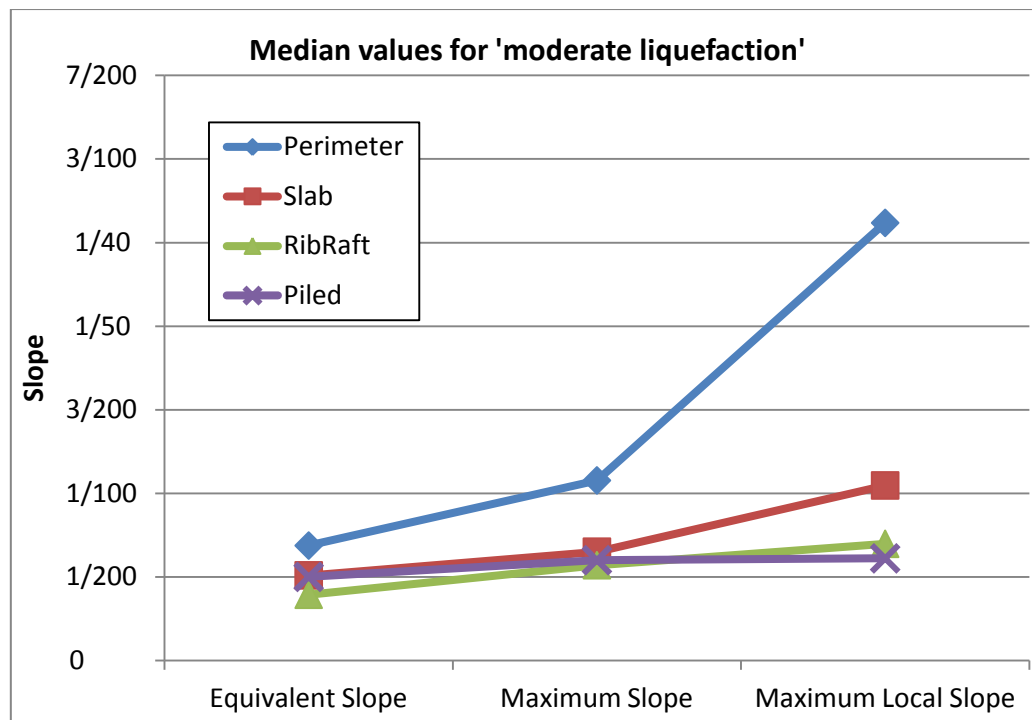
For moderate liquefaction, shown in Figure 4.44, the median floor slopes in concrete perimeter foundations are still considerably higher than those for the three slab-based foundation types. Although the difference is somewhat less than for no liquefaction, it supports the idea that concrete perimeter foundations are damaged more easily than slab-type foundations, and this damage results in higher floor slopes.

Figure 4.44. Median slope values for each foundation, for 'moderate liquefaction', for the three floor slope indices.

Under higher liquefaction levels the performance of the three slab-based foundations is somewhat different. Although there was insufficient data to examine the performance of the three foundation types at high and severe liquefaction levels, even under moderate liquefaction, shown in Figure 4.44, slab-on-grade foundations performed worse than ribraft and piled foundations, particularly in the local sense. This is due to their weaker and relatively more flexible slab that will begin to break up under lower loads. Figure 4.40 and Figure 4.42 show that ribraft and piled foundations both can be expected to require structural repairs due to the higher loads on the foundation at high and severe liquefaction levels, but it is clear that ribraft and piled foundations performed better than slab-on-grade foundations, as at moderate levels of liquefaction there were already significant numbers of slab-on-grade foundations requiring repairs, with two slab-on-grade foundations shown needing rebuilds, one of them with only moderate liquefaction (Figure 4.38). There are no ribraft or piled foundations in these figures that needed rebuilds.

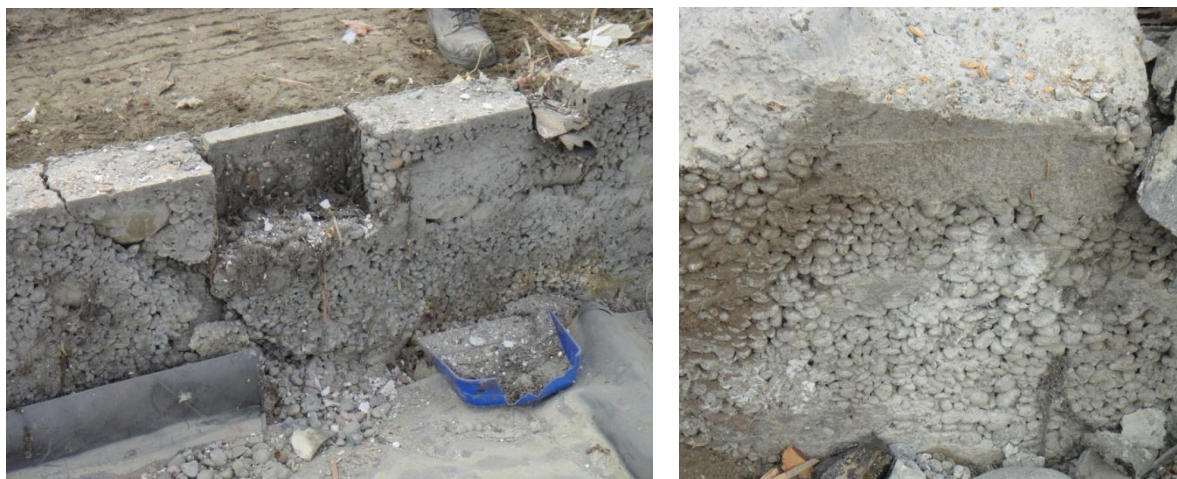
Two of the three concrete perimeter foundations inspected had no reinforcing at all and had quite poor construction, despite being constructed in the 1930-59 period, after the introduction of housing standards. They both used uniformly graded round aggregate, and had very boney concrete mixes. As shown in Figure 5.2, there were extensive areas on the inside of the perimeter walls showing large gaps around the aggregate where very little cement was present.

Figure 5.2. Boney concrete mixes in concrete perimeter walls, (left) large area with little cement fill and (right) close up showing uniform round aggregate.

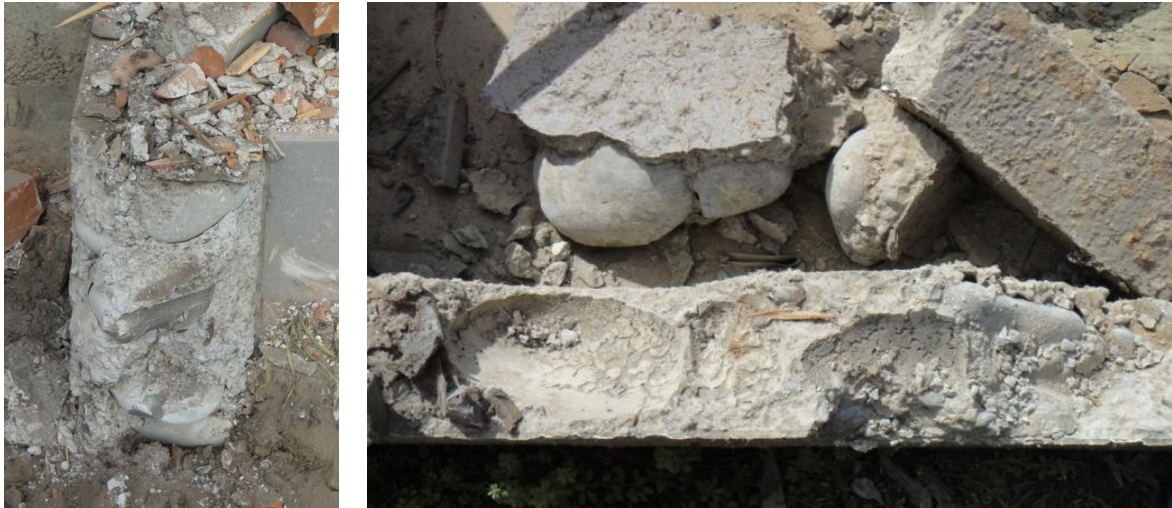
The same two unreinforced concrete perimeter foundations also used large round stones of 200-300mm diameter as fill right through the height of the wall, as shown in Figure 5.3. When the perimeters were lifted up with the excavator by the contractor, the concrete broke smoothly around these stones, indicating they provided a plane of weakness within the concrete wall (Figure 5.3). Similar construction techniques were found in a number of the concrete perimeter foundation houses inspected for the detailed inspections in Chapter 4, where a variety of fills were used, such as bricks and mortar and other pieces of concrete rubble. It is suggested though that the round stones in these two foundations would be the worst case for fill, as they provide no chance for mechanical interlock of the concrete cast around them, and act as planes of weakness.

Figure 5.3. Large 200-300mm diameter stones used as fill in concrete perimeter, (left) showing unreinforced perimeter wall and (right) clean break-up around stones.

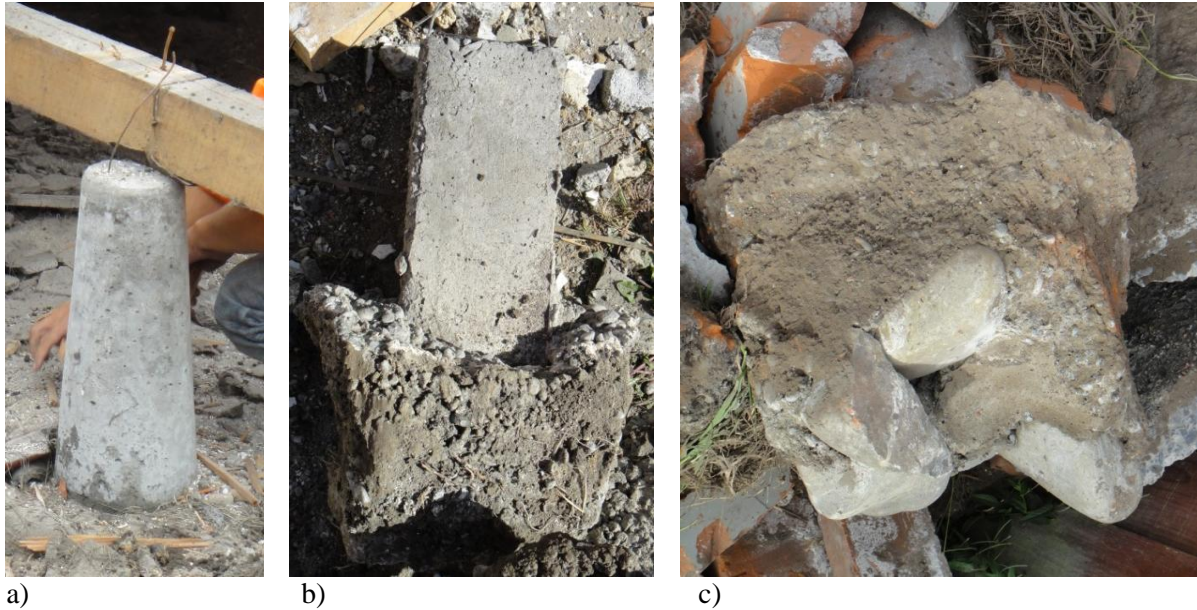
The piers used in each of the houses inspected were all similar. They were either round or square in cross-section and mostly precast, although one house had square cast-in-place piers (Figure 5.4, (a) and (b)). Most piers were cast into the ground by 100-250mm, with footings that were 200-400mm deep and 300-400mm in width. One foundation used large stones as fill in these footings, like in the perimeter walls (Figure 5.4.(c)).

The majority of piers were connected to the subfloor framing with wire hooks that were cast into the piers as in Figure 5.4.(a), although in one house the hooks were not connected at all, with the floor just sitting on top of the piers.

a)
 b)
 c)
Figure 5.4. Pier details, a) round pier connected to floor bearer with wire hooks, b) square cast-in-situ concrete pier with typical footing, c) large stones used in footing.

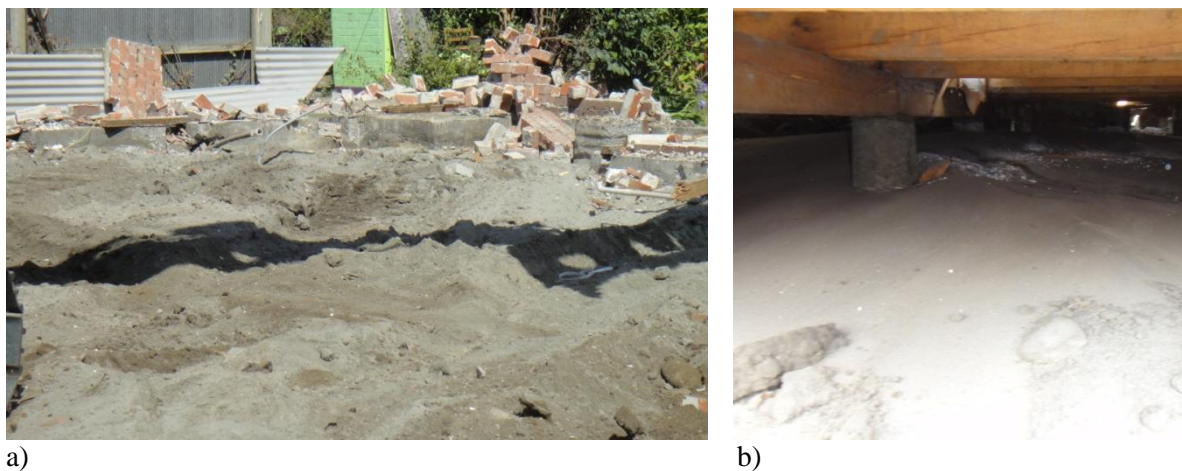
At House #1 there was extensive sand ejecta under half the foundation, up to 200-300mm thick, as shown in Figure 5.5, indicating the likelihood of poor ground conditions below. The soil below the original ground surface was silty sand, very similar to the ejecta at the surface, with no overlying topsoil. This extended to the bottom of the test pit at 1.8m. This is similar to the CPTs analysed from Dallington in Chapter 4, Section 4.4, and indicates that very severe liquefaction was possible, due to the loose, susceptible soils present right to the surface (Figure 5.7.(a)).

a)
 b)
Figure 5.5. Extensive sand ejecta under House #1, a) sand ejecta spread under the whole foundation and b) sand boils up against concrete piers.

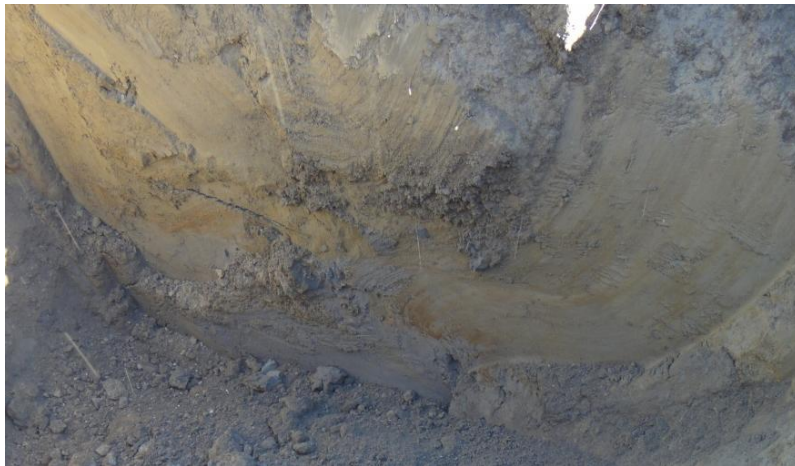
House #2 had far more competent soils close to the ground surface, and no surface liquefaction ejecta was found under the house. From ground level, there was topsoil to a depth of 0.5m, which was underlain by a cohesive but low-plasticity clayey silt to 1.7m (Figure 5.6). Below this was the same grey sandy-silty material seen at the first site to the bottom of the test pit at 2.2m. This sand was moist and when vibrated in the hand quickly became wet on top, indicating susceptibility to liquefaction (Figure 5.7.c)).

Figure 5.6. Competent crust layer of cohesive, low-plasticity clayey silt at House #2.

The presence of the loose silty sand at all three sites at shallow depths shows how poor the general ground conditions were in the suburb where the inspections were conducted. However, the presence of the 1.7m thick crust layer at the second house (Figure 5.6) prevented the liquefied material from breaking the surface there.

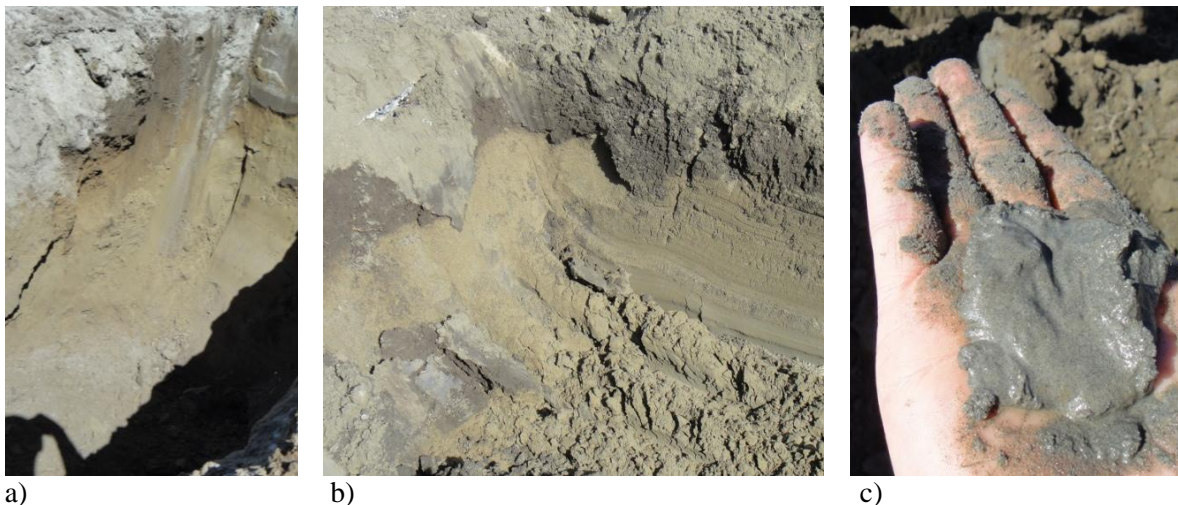
The third house also had extensive liquefaction ejecta under half of the house. Excavation showed a thin 200-300mm layer of topsoil below that, which was underlain by the same silty sand, down to ~0.7m at the bottom of the shallow test pit (Figure 5.7.b)).

Figure 5.7. Soil excavations, a) 1.8m of silty sand under house one, with light grey surface ejecta at top b) shallow topsoil (dark brown) underlain by silty sand with surface ejecta on top, c) wet silty sand after shaking.

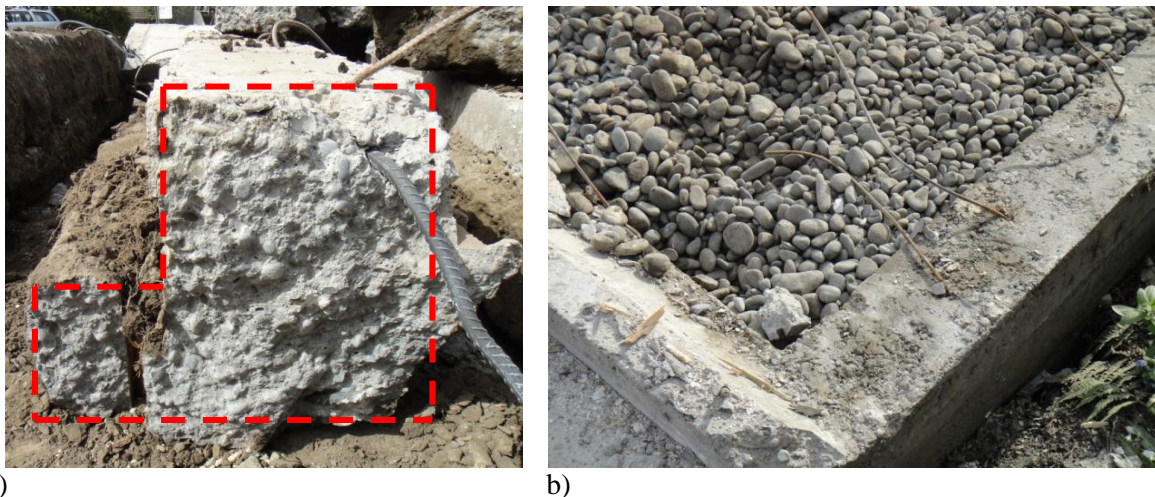
In all four slab-on-grade foundations inspected, the perimeter foundation wall was reinforced with at least two deformed bars. The size and arrangement of these varied from D10 to D16 bars, placed anywhere in the wall, though generally there was at least one near the top and one near the bottom. Three of the foundations also had tie bars between the foundation walls and slab itself (Figure 5.8.(b)).

The walls ranged from 200-300mm wide, and 500-700mm deep, and could be either plain rectangular in cross section or with a wider un-boxed base, as shown in Figure 5.8.(a). One of the foundations also had intermediate foundation walls which were narrower and shallower than the perimeter ones, under each of the major load-bearing walls.

Figure 5.8. Slab foundation details, a) perimeter foundation wall cross-section, showing reinforcing bars protruding, b) foundation wall from above showing tie bars into slab and round river-run fill.

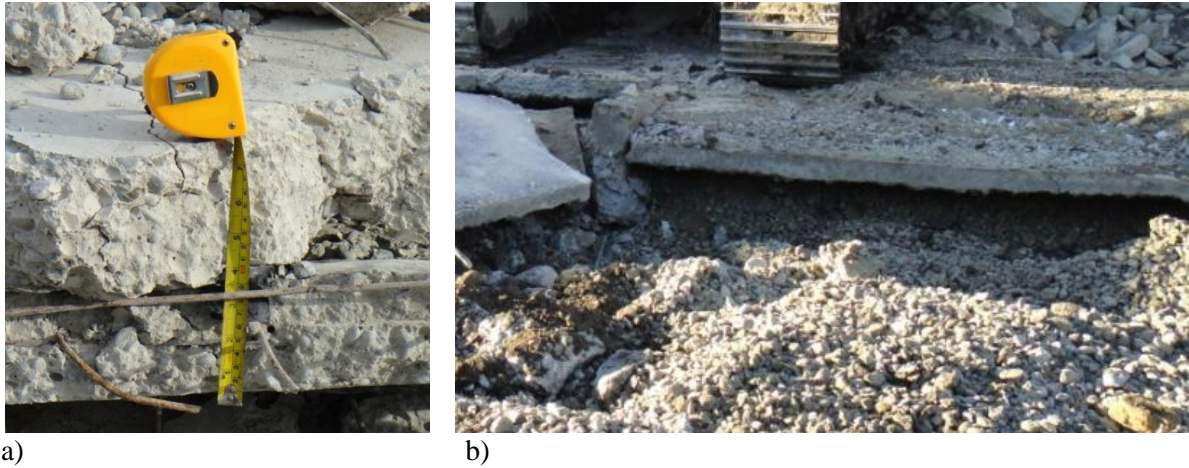
Three of the slabs inspected were very similar, ranging from 95-160mm in thickness, and reinforced with steel wire mesh (Figure 5.9.(a)). The other slab foundation was unreinforced and close to 100mm thick across the whole floor (Figure 5.9.(b)), and overlain by a 50mm thick wood-chip/cement mixture. This somewhat lesser construction was due to the house being constructed in the 1930-59 period, prior to the introduction of residential slab foundation construction standards. This was made up for however by intermediate foundation walls and a more competent fill.

a) b)
Figure 5.9. Slab details, a) two layers of concrete floor slab showing thickness and wire mesh protruding, b) 100mm thick slab over fill.

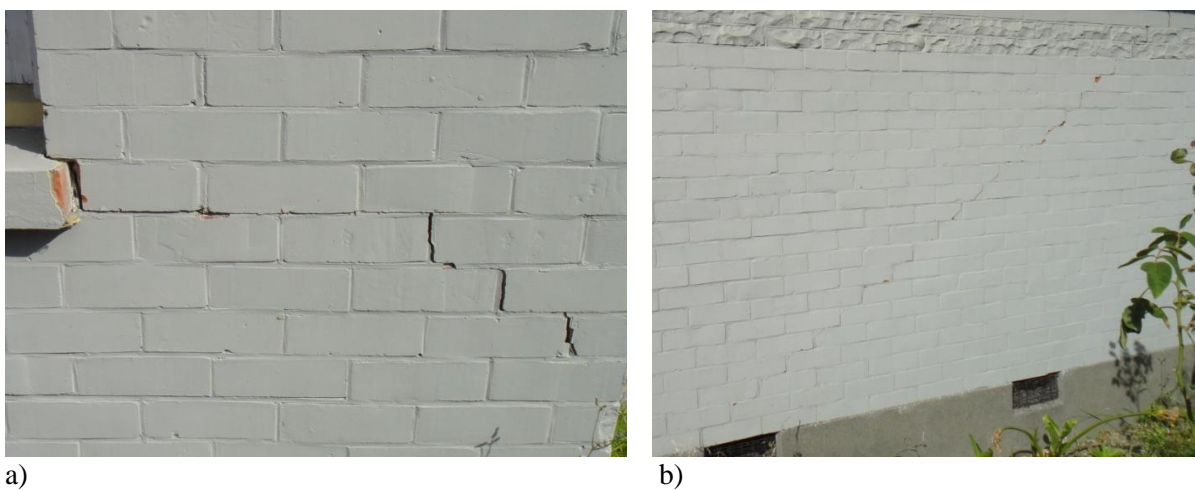
Despite the uniform tilting of the foundation and floor, the superstructure suffered significant damage. There was evidence of racking in a number of locations, with many doors and windows that would not close properly. At the Northwest corner of the house, a large section of the top of the exterior brick cladding had somewhat broken away from the rest of the house which was tilting away from it. This caused horizontal cracks to open up in the brick work from the base of the wall to 10mm width at the top of the wall (Figure 5.11.(b)). This suggests that the superstructure was not strong enough to fully rotate and tilt uniformly with the foundation. As a result the stiff elements (the brick cladding) suffered damage. Due to the flattening out of the floor in the Southwest corner, the walls at this corner would have pushed up against the rest of the structure trying to tilt over with the foundation. This resistance to movement would have been transferred via load paths through the roof structure causing the racking of internal walls and the pushing out of the Northwest corner as described.

Figure 5.11. Structural damage, a) diagonal crack in bricks on North wall at Northwest corner, b) foundation to roof diagonal crack on West wall of Northwest corner.
